Disable wear compensation during removal

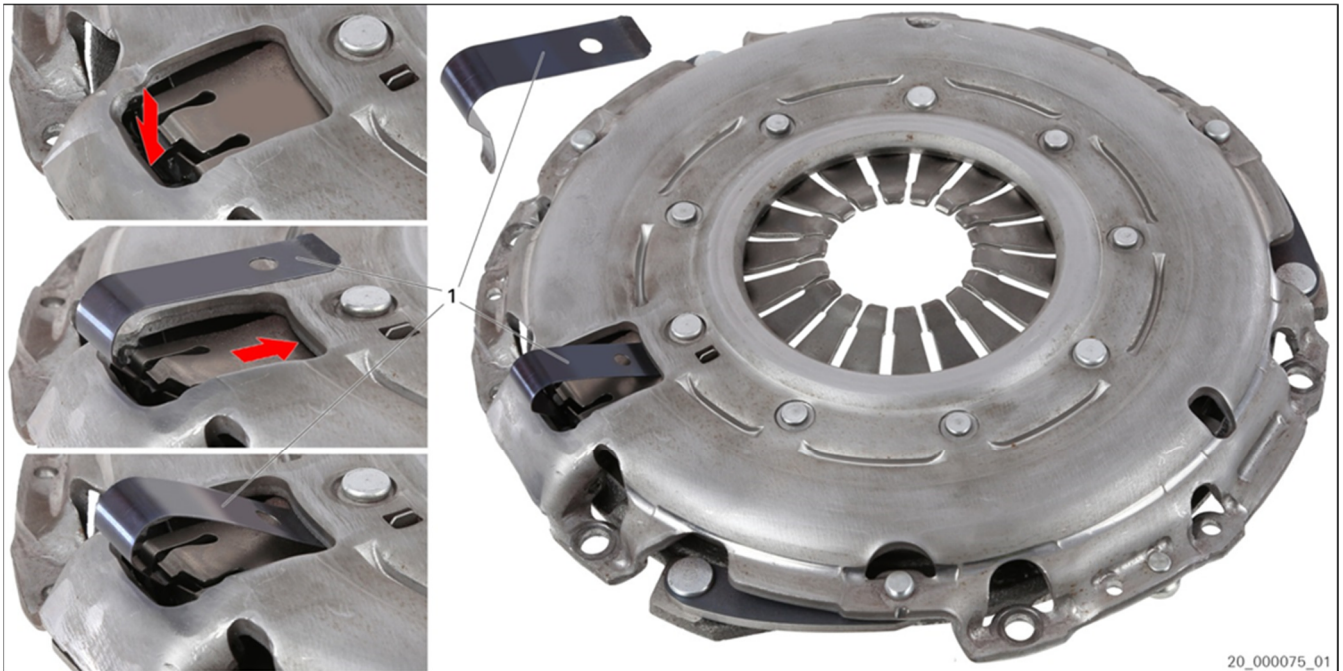
Fig. 1: XTend clutch with with special tool (example)

The special tool (1) jams the adjusting mechanism and thus prevents unintended adjustment of the wear compensation. Perform removal for the purpose of reutilization or survey only with the special tool (1). The special tool is available at your vehicle manufacturer .

1. Special tool (1) insert (Fig. 1).
 → adjusting mechanism is jammed.
2. Remove XTend clutch. Observe the vehicle manufacturer specifications.
3. Remove special tool (1).
