GA357.24

Disassembly/assembly recommendations

IDENTIFICATION OF ACCESSORY BELT TENSIONER ROLLER GA357.24

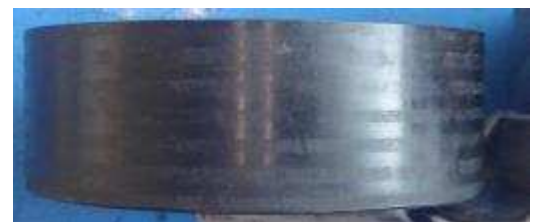
Pulley diameter erosion:

If the belt becomes incorrectly tensioned and moves on the pulley roller, and becomes misaligned. When this happens the polyamide part of the pulley becomes marked and damaged , in some cases the edge of the pulley wears. This wear may allow the belt to slide of the pulley in some situations.

Marks on the pulley

Damaged or worn GA357.24

- It is recommended that the overrunning alternator pulley is checked or replaced at the same time as the tensioner roller assembly is replaced , to avoid any premature failure. To find the correct part number for your vehicle , refer to the NTN-SNR Auxiliary catalogue online.
- It is recommended that the correct tools are used to fit the tensioner, OAP and belt to the manufacturer's specifications.
- The condition of the pulleys and belts should be checked a regular intervals.

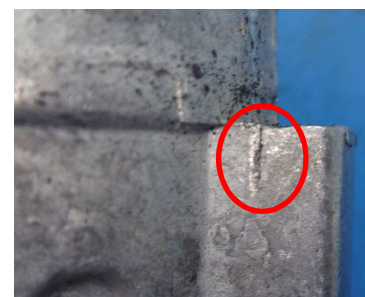
Tensioner GA357.04 is not designed to absorb the violent shocks caused by the bouncing and snatching of the belt. This bouncing and snatching motion prematurely wears the internal elements of the tensioner.

Marks on the stop

Marks on the stops show us the tensioner arm has been bouncing back and forth off the tensioner stops. When the tensioner is working correctly, the tensioner arm operates in between the two stops but never touches them .

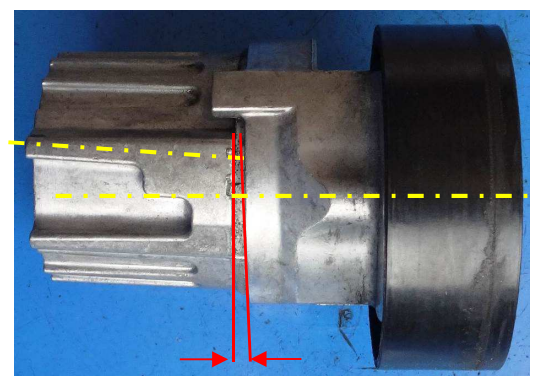
Worn central axis

A worn axis caused by belt misalignment, means the tensioner bends in the middle causing further belt misalignment.

Failures with GA357.24 are often caused by a faulty overrunning alternator pulley. Overrunning alternator pulleys should be checked or replaced at the same time as the tensioner roller assembly is replaced. Failure of the accessory drive system can cause the vehicle to stop running , in severe cases the accessory belt enters the timing system causing major damage.
