**SERVICE  
ENGINEERING  
BULLETIN**

# **SB2191.1**

## **Valve Breakages VAG 1.8 20V Petrol & 1.9TDI Diesel Engines**

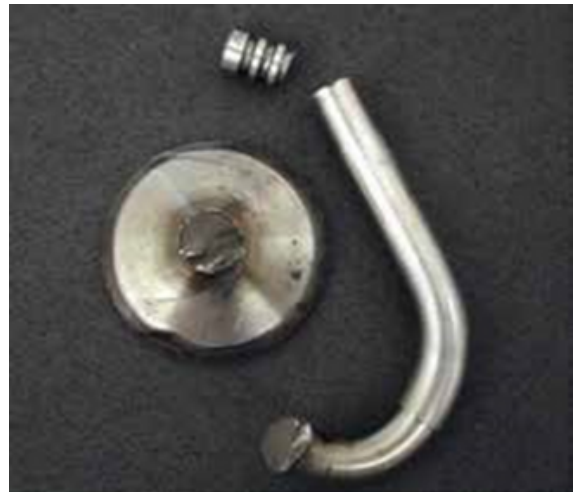
**Photo 1**

Over extension / "pump-up" of hydraulic lifters.  
Incorrect seating of valve spring to cylinder head.

Photo 1 : Probable cause - hydraulic lifter.

1. When fitting new valves, if possible fit new hydraulic lifters.
2. Ensure all components are pristine clean.
3. Apply lubricant to all hydraulic lifters.
4. Take extreme care to seat all valve springs correctly in the recess of the cylinder head.
5. Renew engine oil and oil filter.

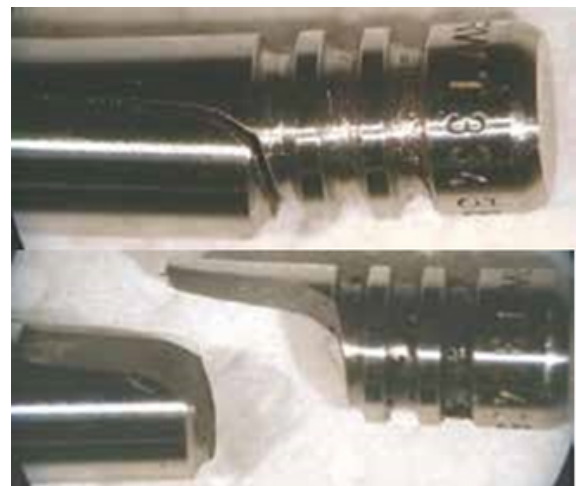
**Photo 2**

Photo 2 : Probable cause - incorrect location of valve spring.
