## **Valve Face Wear**

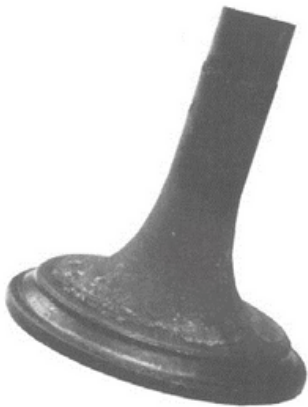
**Exhaust Valve Face Wear**

This does not usually effect modern engines. Engine manufacturers spot its occurrence during development, and correct it, typically by the use of a stellite seat. However, on earlier engines without hard faced seats valve face pounding and wear can occur. This is due to high engine temperatures, coupled with slack tappets or weak valve springs.

Before the use of non-leaded fuels and LPG, the products of combustion adequately lubricates the exhaust valve. However, the exhaust gases in these fuels are relatively dryer and lubrication free. This increases valve face wear; revision of valve geometry, valve and seat materials and cast iron head metallurgy prevents it

- High engine temperature coupled with excessive tappet clearance, weak valve springs etc.
- Valve to port seat misalignment.
- Engine operated on either low lead or LPG fuel (Petrol engines)

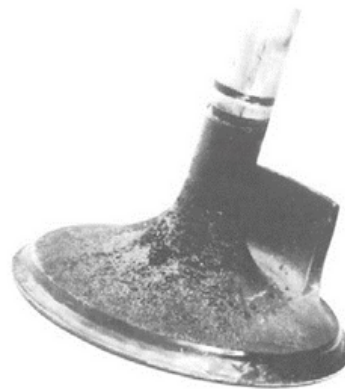
**Inlet Valve Face Wear**

Inlet Valve Face Wear is specific to turbocharged diesel engines but not to turbocharged petrol engines. Turbocharging naturally increases the pressure during the induction stroke. However, it also increases air pressure in the inlet port to above atmospheric. This prevents the air stream carrying any lubrication oil from the valve guide. Consequently, the valve face and seat run dry. Wear can occur on either, though in practice mainly on the valve face.

Although similar conditions occur in the turbocharged petrol engine, the wetter fuel provides inlet valve and seat lubrication.

- Caused by "dry" valve seating resulting from high inlet port pressures and subsequent lack of lubricating oil mist drawn from the valve guide. Ensure to fit materials that are to the correct specification.
