KB659.26/KB659.27

Assembly recommendations

CITROËN: Jumper (I, II, III), Relay (II, III)	OE reference
FIAT: Ducato (I, II)	1610531680
PEUGEOT: Boxer (I, II, III)	5031-78
	9405031789

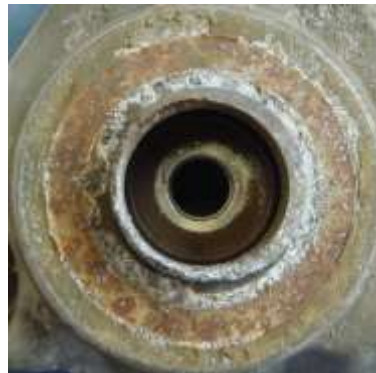
PREMATURE FAILURE OF THE STOP

Probable cause

Improper installation of the kit.

Failure is linked to some kind of pollution being introduced; it is important to change all the parts and especially to follow the reassembly instructions correctly.

This failure is a result of an inverse assembly of the two stops and two joints (see assembly process).

- Observe the direction of the stop: dark side of the stop to the filter block side.
- Observe the direction of the seal: sealing lip on the filter block side.
- Careful not to deform the joints during assembly and do not overly lubricate the two sets.

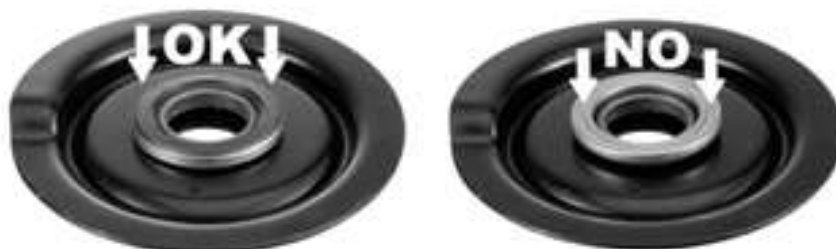
Observe the direction of the stop: metallic side not visible

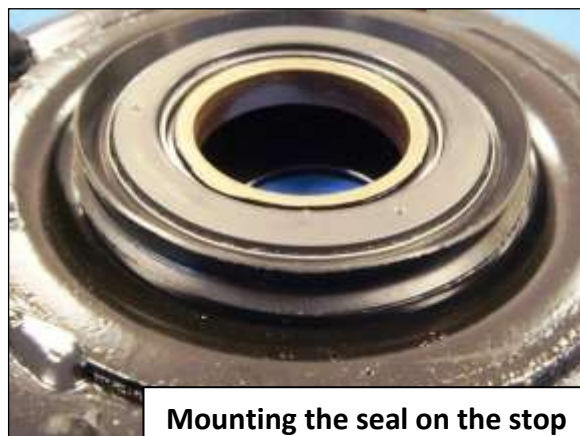
Mounting the seal on the stop

Observe the direction of the seal: sealing lip on the filter block side
