TROUBLE TRACER CHART CAMTRAIN

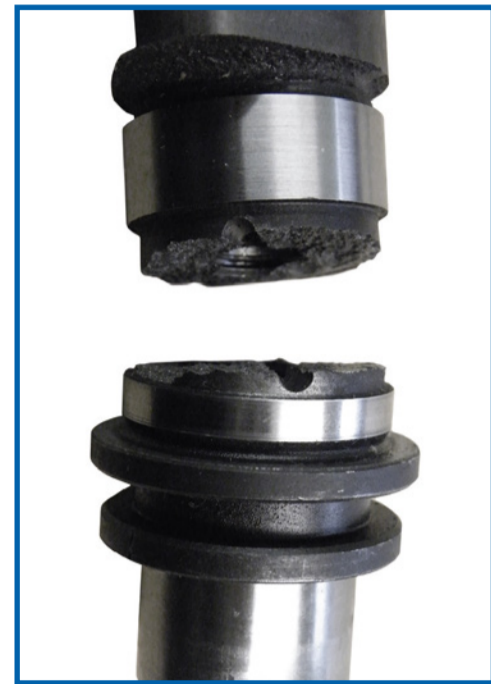
Broken camshaft

Appearance: Camshaft breakage between or through cam-lobes.
Causes: Distorted camshaft housing or cylinder head. Incorrect torque sequence and mishandling can also cause similar breakage.
Remedy: Straighten or replace camshaft carrier/cylinder head, use correct bolt torque sequence and handle with care. Thoroughly flush the lubricating system, replace cam and followers, prime with extreme pressure lubricant and replace oil and oil filter.

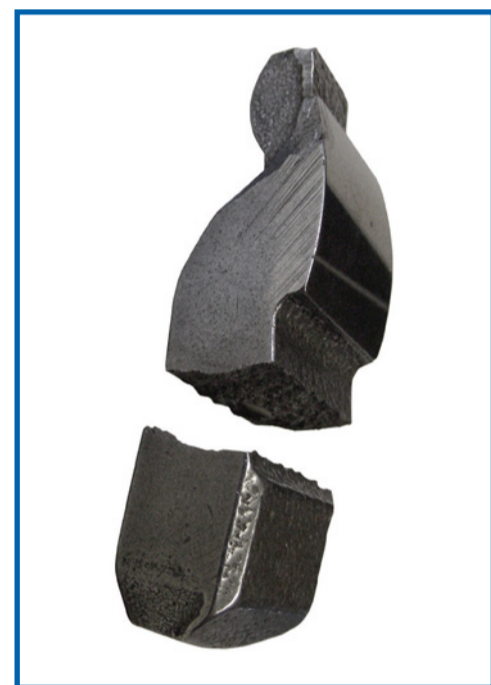
Follower breakage

Causes: Mechanical overload resulting from:
1 Sticking or seized valve, resulting in the follower to break due to cam-lobe pressure.
2 Piston contact with the valve due to:
 a Weak valve spring
 b Over extended hydraulic lifter
 c Incorrect assembly of valve tip-cap
 d Timing belt breakage
 e Or through over high revving of engine.
3 Incorrect valve timing.
Remedy: Investigate & rectify the mechanical overload cause. Thoroughly flush the lubricating system, replace all damage components, prime cam and followers, with extreme pressure lubricant and replace oil and oil filter.

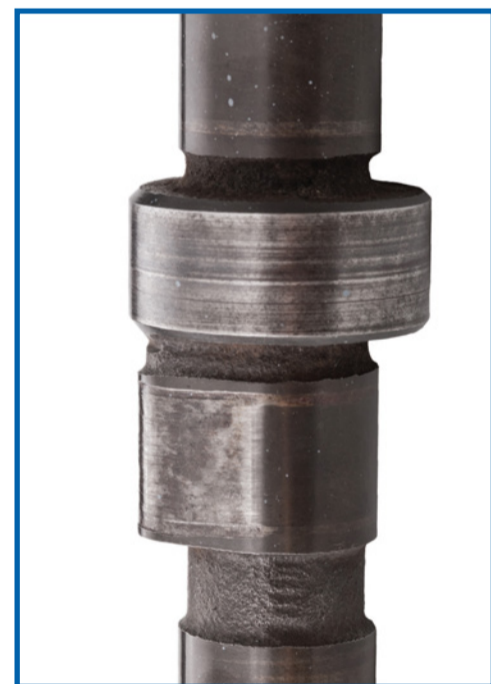
Excessive cam-lobe wear

Appearance: Severe cam-lobe wear.
Causes: Starvation or contamination of oil, tappet clearance too tight, excessive valve spring pressure.
Remedy: Thoroughly flush the lubrication system, install new camshaft and followers. Adjust tappets to the correct clearances, prime with extreme pressure lubricant and replace oil and oil filter.

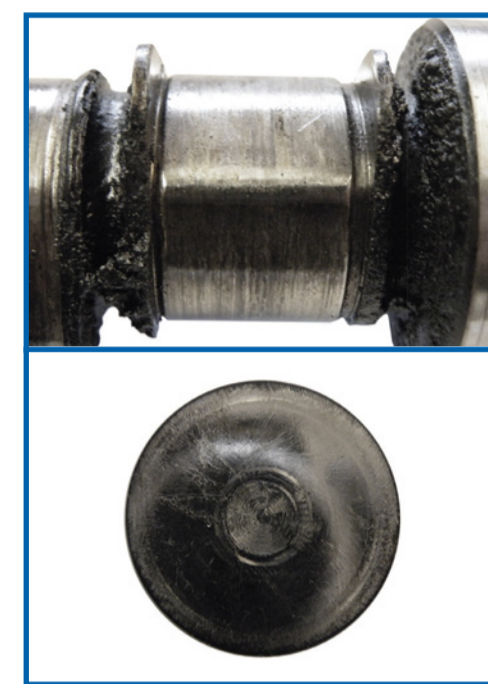
Cam-lobe and follower wear

Appearance: Premature wear of one or more cam-lobes & followers. Follower contact surface will be concaved with chipped edges.
Causes: Incompatible cam-lobe & follower contact surface geometry. Often caused by fitting new camshaft with old followers or vice versa. Can also result from lubricant starvation from blocked or restriction in oil supply.
Remedy: Thoroughly flush the lubricating system, replace cam and followers, prime with extreme pressure lubricant and replace oil and oil filter. Do not mix old and new components.

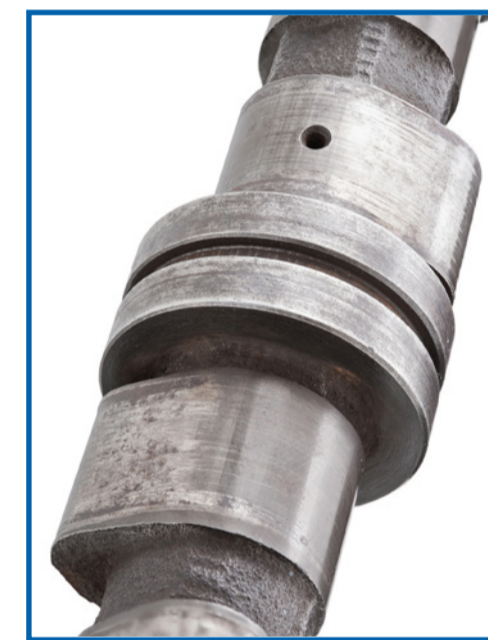
'Scored' bearings

Appearance: Severe scoring of the camshaft bearings.
Causes: Starvation or contamination of oil, i.e. foreign particles circulating in oil.
Remedy: Thoroughly flush the lubricating system, replace cam and followers, prime with extreme pressure lubricant and replace oil and oil filter.

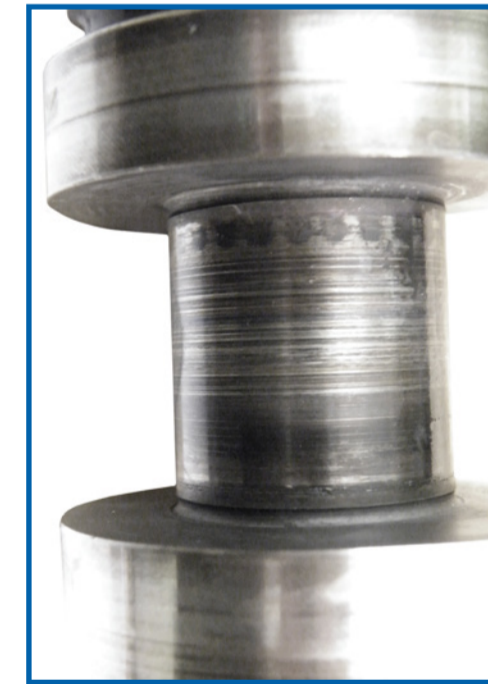
Overheated camshaft

Appearance: Cam-lobes, bearings & followers have a 'blue' discoloration.
Causes: Overheated engine possibly due to cooling failure.
Remedy: Investigate and rectify the cause of the overheating. Thoroughly flush the lubricating system, replace cam and followers, prime with extreme pressure lubricant and replace oil and oil filter.

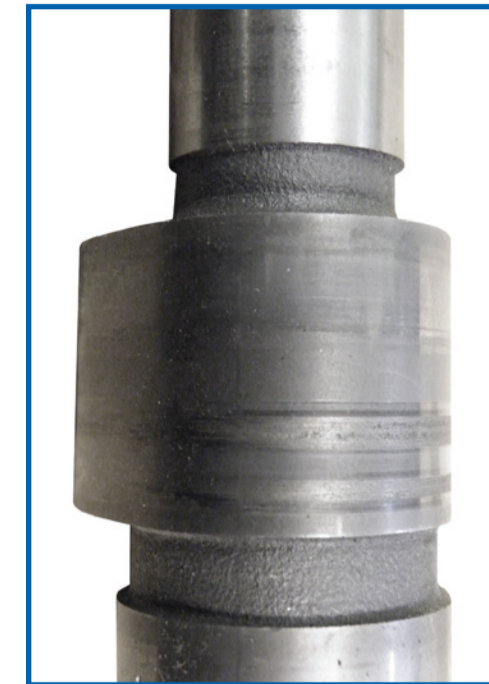
Base circle contact marking

Appearance: Witness marking on base circle of cam-lobes, biased to one side.
Causes: Worn hydraulic lifter and/or retainer springs.
Remedy: Replace cam and followers if marks are deep, otherwise set tappets to correct clearance. Thoroughly flush the lubricating system and replace oil and filter.

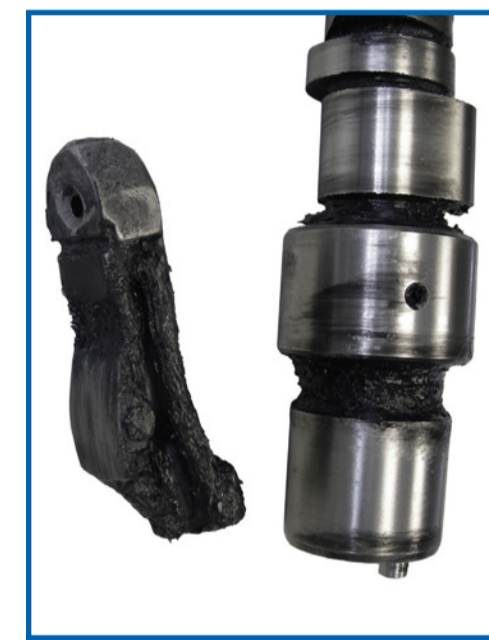
Carbonised oil deposits

Appearance: Carbonised oil build-up on cam and followers.
Causes: Excessive operating temperatures resulting from marginal lubrication conditions due to contaminated lubricating oil or blockages/restrictions in oil feed galleries.
Remedy: Thoroughly flush the lubrication system, ensuring that all galleries and hydraulic lifters (where fitted) are free from blockages & debris. Install new camshaft and followers, prime with extreme pressure lubricant and replace oil and oil filter.

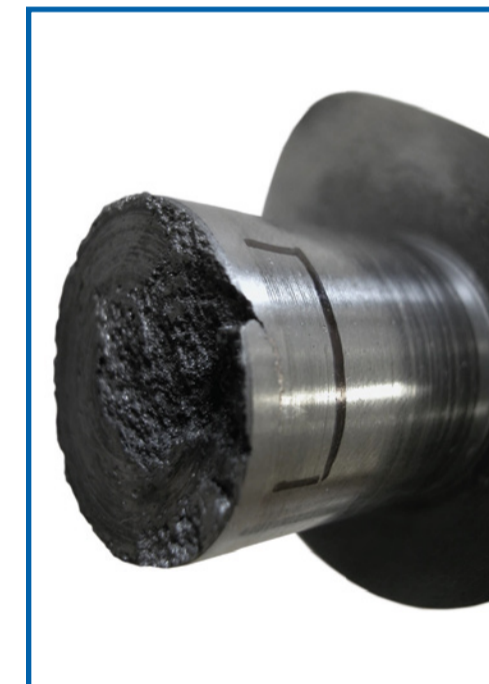
Physical damage to camshaft & followers

Appearance: Cam-lobes, bearings & followers "chipped".
Causes: Excessive end-float due to:
 a Worn thrust washer
 b Loose distributor
 c Worn distributor drive gear
 d Or misaligned timing gears
Remedy: Investigate and rectify the cause of the damage. Thoroughly flush the lubricating system, replace cam and followers, prime with extreme pressure lubricant and replace oil and oil filter.
