TROUBLE TRACER CHART VALVE TRAIN

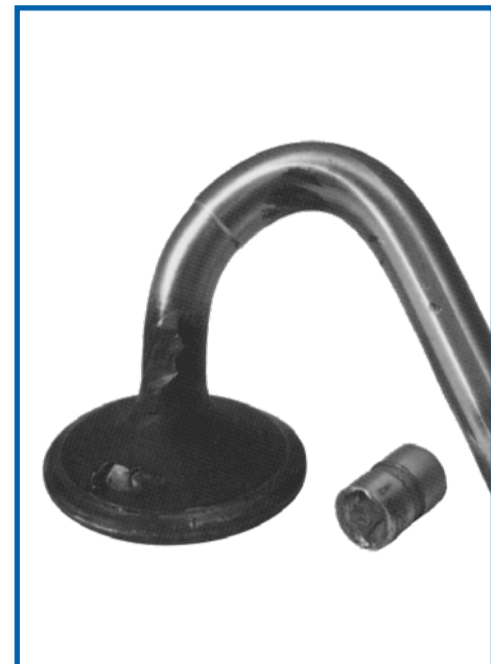
Stem breakage through collet groove

Symptom: Excessive mechanical noise, bent stem and possible head detachment.
Cause: Poor assembly allowing uneven loading. Poor handling, dropping etc. Bouncing the valve after fitting by hitting the tip with a hammer. Valve bounce from excessive seating velocity.
Remedy: May not be possible due to extreme damage this failure can cause, however: Check seats, guides, springs, pistons and bores for damage and repair where necessary. Do not overspeed the engine.

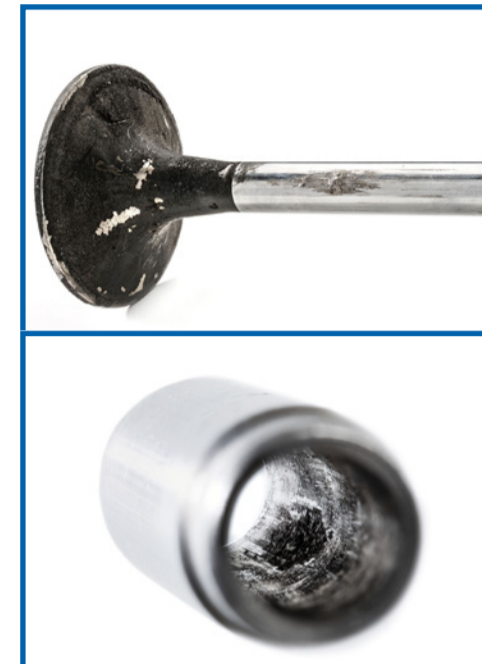
Scuffed/sticking valve stem

Symptom: Poor performance due to low compression. Mechanical breakage due to sticking valves.
Cause: Marginal lubrication from inadequate valve to stem clearance, causing scuffing or metal transfer. This may ream out the valve guide leading to the second cause, excessive oil from too great a clearance carbonising on the stem to cause sticking.
Remedy: Ensure the valve stem to guide clearance is to specification. Ensure the correct valve stem seals have been used. Replace worn components where necessary.

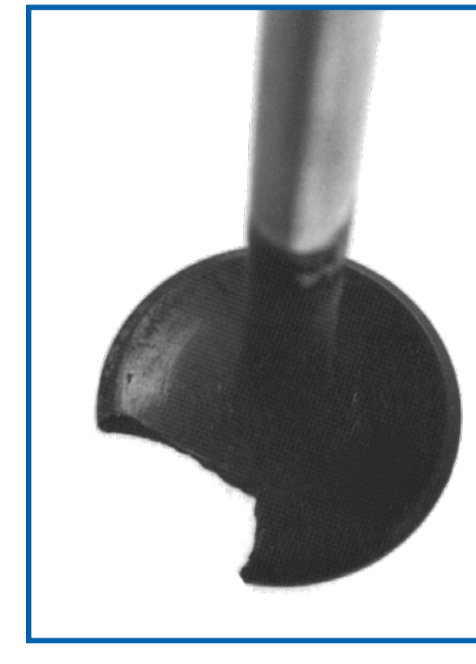
Radial cracking of valve head, leading to a triangular segment breaking off

Symptom: Sudden mechanical noise. Rough running. Possible seizure.
Cause: Poor temperature distribution across the valve head resulting in high tensile stresses in the rim, often combined with severe deflection due to abnormal combustion pressures and temperatures. Extreme thermal cycles, (continual sudden changing from full power to shut-down). Damage marks on the rim producing stress raisers. Mechanical overload from valve bounce.
Remedy: Check the remaining valves for signs of cracking, replace where necessary. Ensure the correct valves have been used. Check engine settings, valve springs, guides and followers. Do not overspeed the engine.

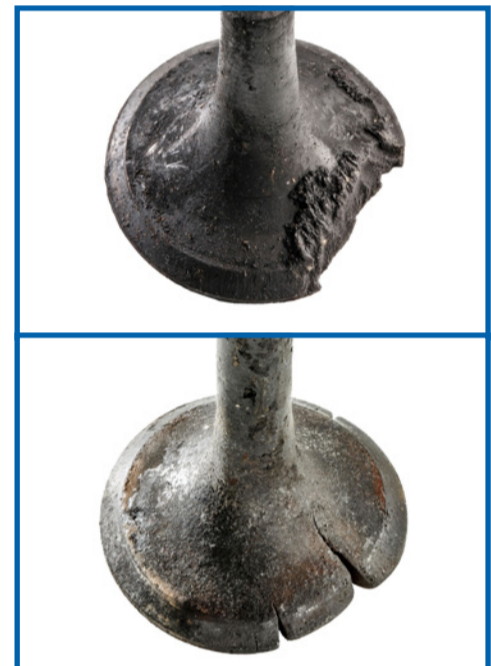
"Gutter" burnt through valve rim

Symptom: Loss of power. Rough running.
Cause: Valve clearance too small holding the valve off its seat. Sticking stem, poor/uneven seating or misalignment of the valve assembly. Overheating from pre-ignition. Excessive build up of carbon which flakes off the valve face to form a gas leakage path. Hard carbon particles peen into the seat surface until enough indentations line up to form a gas leakage path.
Remedy: Ensure valve clearance is to specification. Check stem to guide clearance and for any misalignment of the valve assembly. Check engine timing, carburettor settings and injection timing.

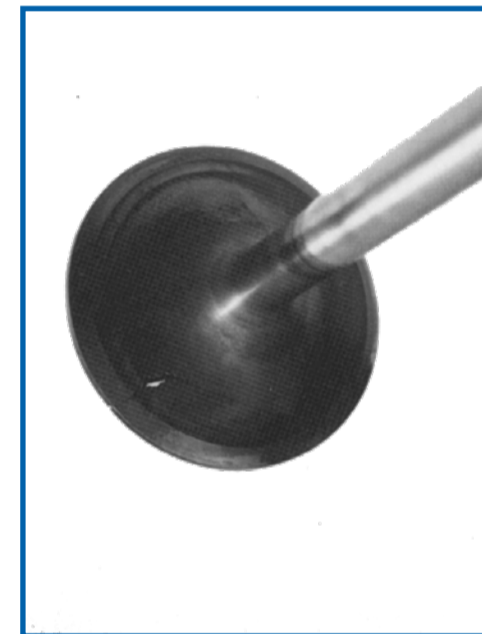
Blow hole through valve head, starting from a radial crack

Symptom: Rough running. Loss of compression. Poor starting.
Cause: Similar to a segmental breakage, but gas escapes through the crack and burns a hole. Extreme thermal cycles (continual sudden changing from full power to shut down). Damage marks on the rim producing stress raisers. Mechanical overload from valve bounce.
Remedy: Check remaining valves for signs of cracking, replace where necessary. Ensure the correct valves have been used. Check engine settings, valve springs, guides and followers. Do not overspeed engine.

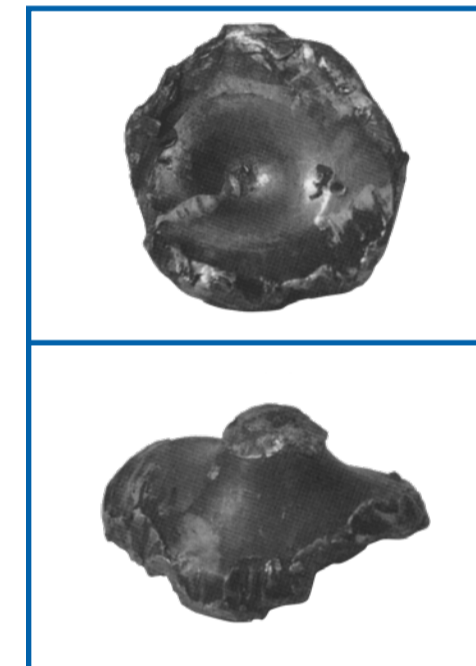
Valve head breaking off stem

Symptom: Rough engine with sudden mechanical noise.
Cause: Mechanical overload, such as seating velocity too high from excessive valve clearances. Valve bounce, valve to piston contact caused by overspeeding, weak or broken valve springs or sticking valve stem. Uneven seating due to misalignment or distorted valve.
Remedy: May not be possible due to extreme damage this failure can cause, however: Check valve springs, guides and alignment and repair where necessary. Check seat guides, pistons and bores for damage. Reset the valve clearances.

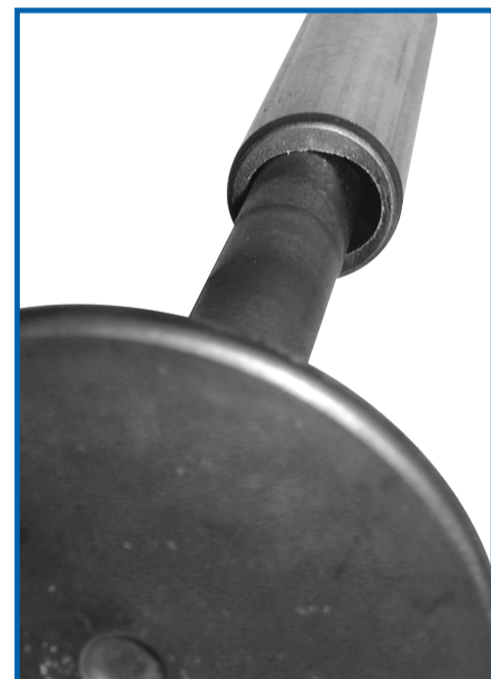
Excessive valve stem and guide wear

Symptom: Valve gear noise, high oil consumption, exhaust smoke on initial start up.
Cause: Too great or too small valve stem to guide clearance. Poor valve stem lubrication or ingress of dirt through the air intake system. It should be noted that the cause of this problem is not always obvious. Unless the cause is readily apparent, additional advice should be sought.
Remedy: Ensure correct valve and guides are fitted. Check alignment, valve stem to guide clearances, valve stem seals and lubrication system.

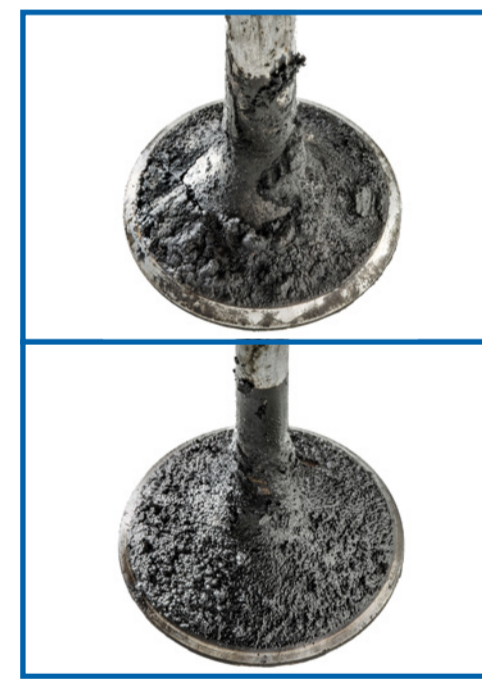
Inlet valve underhead carbon build-up

Symptom: Poor starting. Loss of power. Blue smoke from exhaust (when throttle closed).
Cause: Excessive clearance between valve stem and guide. Valve stem seal failure or wear. Excessive oil supply due to blocked drainage paths. Incorrect grade of lubricating oil used.
Remedy: Check valve stems, guides and stem seals for wear and replace where necessary. Ensure there is no blockage in the engine drainage or breathing systems.

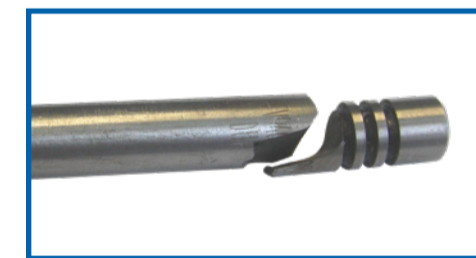
Valve breakages -fracture at lower cotter groove

Symptom: Valve breakage shortly after cylinder head rebuild, during initial start-up or during test run.
Cause: Over extension / "pump-up" of hydraulic lifters (photo 1). Incorrect seating of the valve spring to the head (photo 2). Engine over-speed or weak springs.
Remedy: Where possible fit new hydraulic lifters with new valves. Ensure the engine block is thoroughly cleaned to remove all traces of debris. Take extreme care to seat all valve springs correctly in the recess of the cylinder head. Renew engine oil and replace oil and air filters.
