Valve Face Burning

1. Exhaust Valve Guttering - Fig. 1

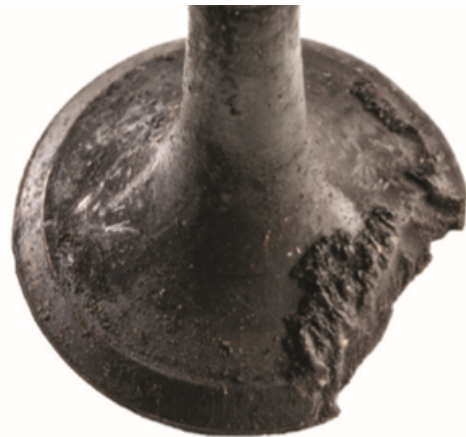
Fig. 1

This refers to exhaust valve burn out that is local; usually in one location or but possibly appears in other areas. The burn out will form a deep channel in the valve head. Radial cracks may develop, or pieces may even break away, depending on the design of the valve head and if left running too long.

With both austenitic valve heads and hard-faced valves (stellite etc.) the likely causes are:

a. Lack of tappet clearance results in light seating and carbon build up on the seating face. Both factors lead to destruction of the thermal heat path outlet from the valve face through the valve seat to the coolant. This causes a considerable rise in valve head temperature, particularly in the valve face area. Eventually, the conditions exceed the material's resistance to hot corrosion or burning. As the localised gas leak increases, so does the torching effect through the gap, eventually producing the characteristic gutter.

b. High carbon deposit build up between the valve face and seat caused by over-rich combustion, excessive oil consumption, etc. This also destroys the thermal path and ultimately leads to valve burn out. However, partial breakaway of these deposits can accelerate failure by causing localised gas leakage.

c. Nickel based alloys have a high hot corrosion resistance but are weak in the erosion phase when torching occurs. Therefore, their rare but characteristic mode of failure is nearly always a deep gutter due to a local gas leak.

d. Pre-ignition due to incorrect air/fuel ratio, inaccurate timing or incandescent hot spots on the valve head periphery. These produce high gas loads and localised temperatures, which sometimes lead to guttering. In some engines, piston failure occurs before the valve shows signs of distress.

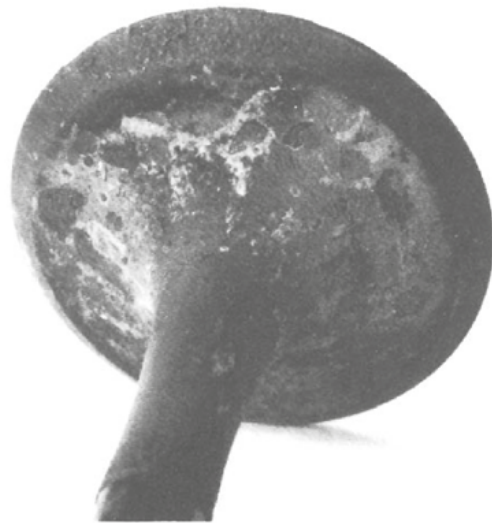
3. Exhaust Valve Broad-Face Burning - Fig. 2

This applies to burnt valves where there is no deep gutter or local channelling. The affected area extends for a distance around the valve face. The valve material burns or corrodes away more or less evenly. This allows gas to escape through a very narrow gap over a wide area, with resultant loss of performance. Non-hard faced valves are more prone to this, the likely causes of this type of failure are:

a. Misalignment between the valve head and seat brought about by –

- Incorrect alignment of the valve guide to seat
- Inherent valve bridge weakness
- Engine overload
- Valve head distortion due to poor cooling etc.

b. Valve springs too weak.

c. Valve seat insert movement.
