Valve head cracking / breaking

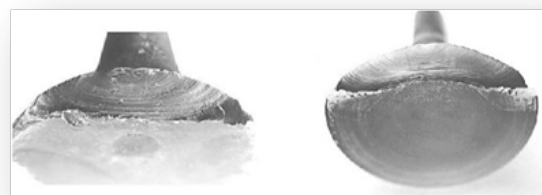
1. Valve Headchordal Failure

This is the most typical form of valve head failure. The valve head breaks through a chord line, i.e. a failure stretching across two points on the circular edge of the valve head. This usually produces considerable secondary damage to the piston, cylinder head and sometimes the cylinder bore.

This is a fatigue type failure, the causes of which are:

- The valve head's inability to stand up to the stresses from the gas loading.
- The valve head temperature effect on the ultimate tensile strength of the valve material.

The initiation point is usually about halfway up the underhead radius. This does vary to some extent according to the section design of the valve head. This is a problem mainly confined to the engine manufacturer during the development of a new or uprated product but it can occur in service.

Although the term chordal is applied, there may be many variations on the shape of the developing crack. This sometimes travels a considerable way round the underhead radius before propagating out to the valve seat. Fundamentally, the skin of the underhead radius at some point being too highly stressed causes such valve head failures. In service the reasons for this could be:

- a. Excessive load on the engine coupled with over-fuelling or other maladjustment, resulting in excessive valve temperature and gas pressures.
- b. Poor finish on the underhead radius on highly stressed valves. Note, some valves are shot peened or spiral-polished to increase resistance to skin fatigue.
- c. Damage marks on the underhead radius.

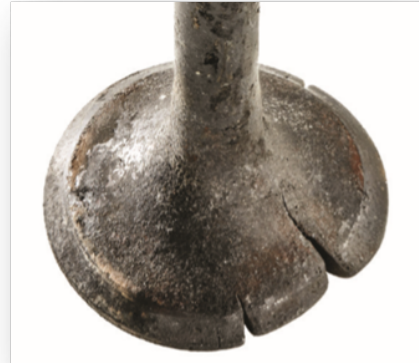
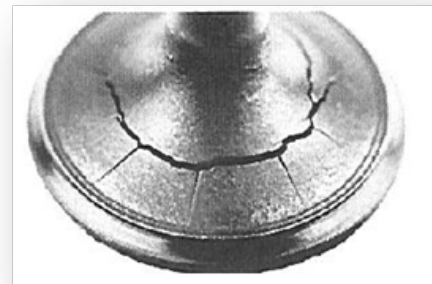
4. Burn Through On Rear of Valve Face

On occasions, a hole burns through the exhaust valve head at the back of the seating face that leaves the seating face virtually unmarked. Close examination, however, shows the start of the failure is a rim crack. With rapid erosion of the valve head material, combustion gases can escape through the crack. This is also another example of radial rim cracking or, thermal fatigue.
