GA357.24

Disassembly/assembly recommendations

IDENTIFICATION OF ACCESSORY BELT TENSIONER ROLLER GA357.24

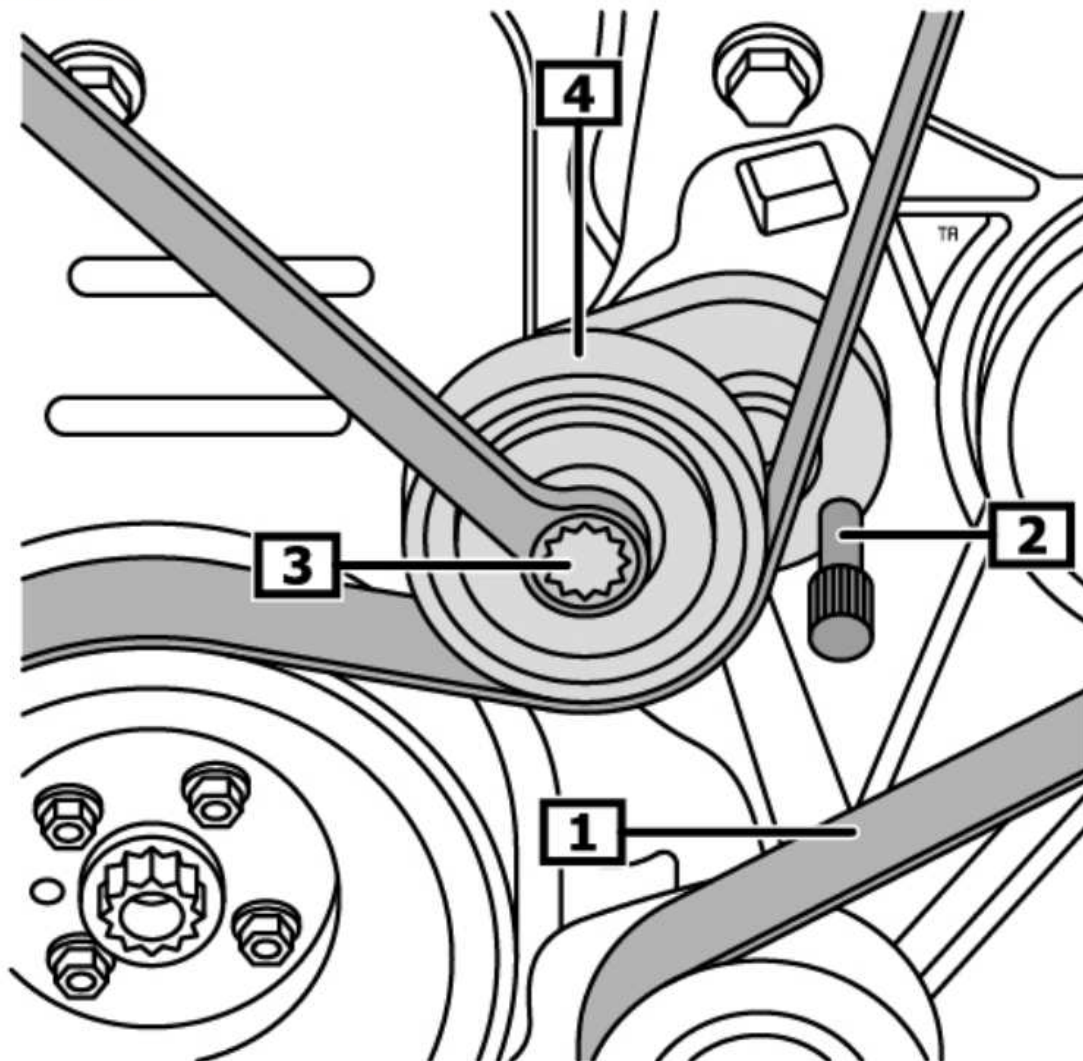
Illustration 2

| 1 Auxiliary belt | 2 Locking pin |

- 1- Install the new GA357.24 making sure it is correctly located and torque according to the vehicle specification.
- 2- Refit a new belt (CA6PK1072) checking it is located on the pulleys correctly , never use an old belt.
- 3- With a spanner on the roller nut , rotate the tensioner fully clockwise.
- 4- Remove the locking pin and gently let the tensioner return to the rest position
