TROUBLE TRACER CHART VALVE TRAIN

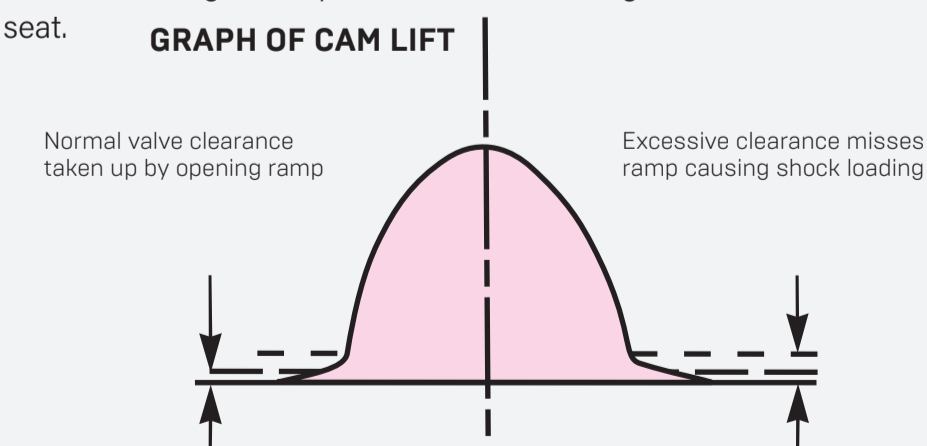
- Initial valve opening and final valve closing occurs very gently. Cam lobe profiles include lifting and lowering ramps to achieve this.
- Ensure the valve clearances are not too great to prevent the valve being hammered open or dropped onto its seat.

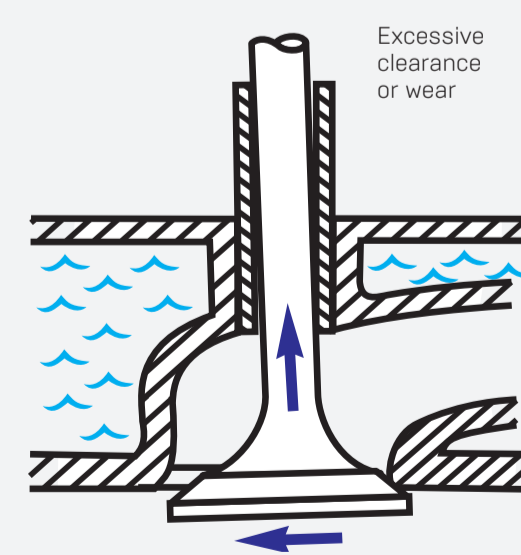
- The valve seat must be concentric with the valve guide. Any eccentricity that exists between the valve seat and guide will force the valve sideways.
- Excessive valve guide wear will occur as a result of this which can lead to a fatigue failure of the valve stem.

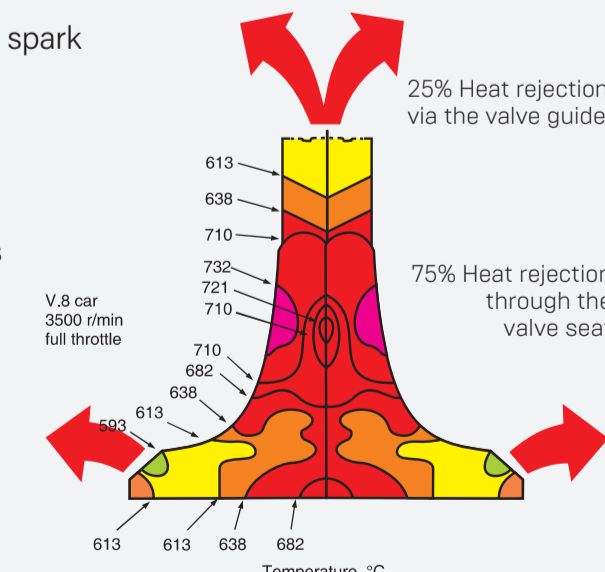
- Typical exhaust valve temperature distribution in a spark ignition engine. Figures are degrees in centigrade.
- An exhaust valve may operate at up to 800 °C, and 75% of its cooling is by transferring heat to the valve seat.
 - Ensure the valve seat contact is correct and as specified by the engine manufacturer.
