## IMPORTANT INSTALLATION NOTICE

## Automatic transmission filter with oil pan 8020015 and 8020016

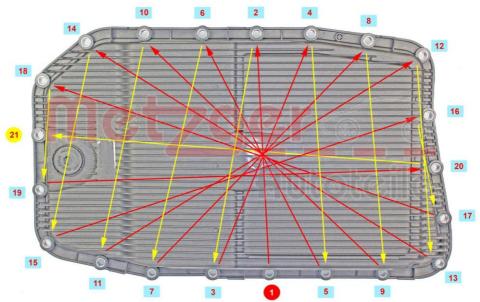
Uptight mounted oil pans cause oil leaks and cracks in the oil pan itself. **Note the tightening sequence during installation!**

**Tightening sequence:** Keep oil pan on the gearbox and screw all screws in by hand. Check correct fitment of the oil pan. Start fasten screws at position 1 crosswise from inside to outside. Torque 10 NM. The car manufacturer's instructions must be observed.

Leaks or cracks through uptight mounted oil pans are not recognized as a quarantee case.
