MEYLE-HD: Better than OE.
Full-rubber bushing

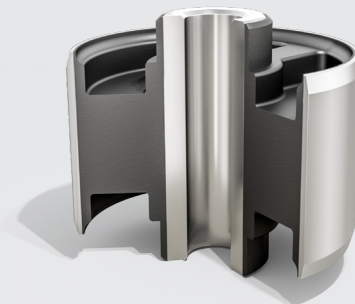
MEYLE-HD

Full rubber bushing

Solution

- Full-rubber bushing with optimized rubber shape and a larger bonding surface

Advantage

- No risk of leakage
- Significantly longer service life
- 4-year warranty
